National Register of Historic Places Inventory—Nomination Form

historic Czech Folk Architecture of Southeastern South Dakota

title Czech Folk Architecture of Southeast—has this property been determined eligible? ___ yes no
ern South Dakota

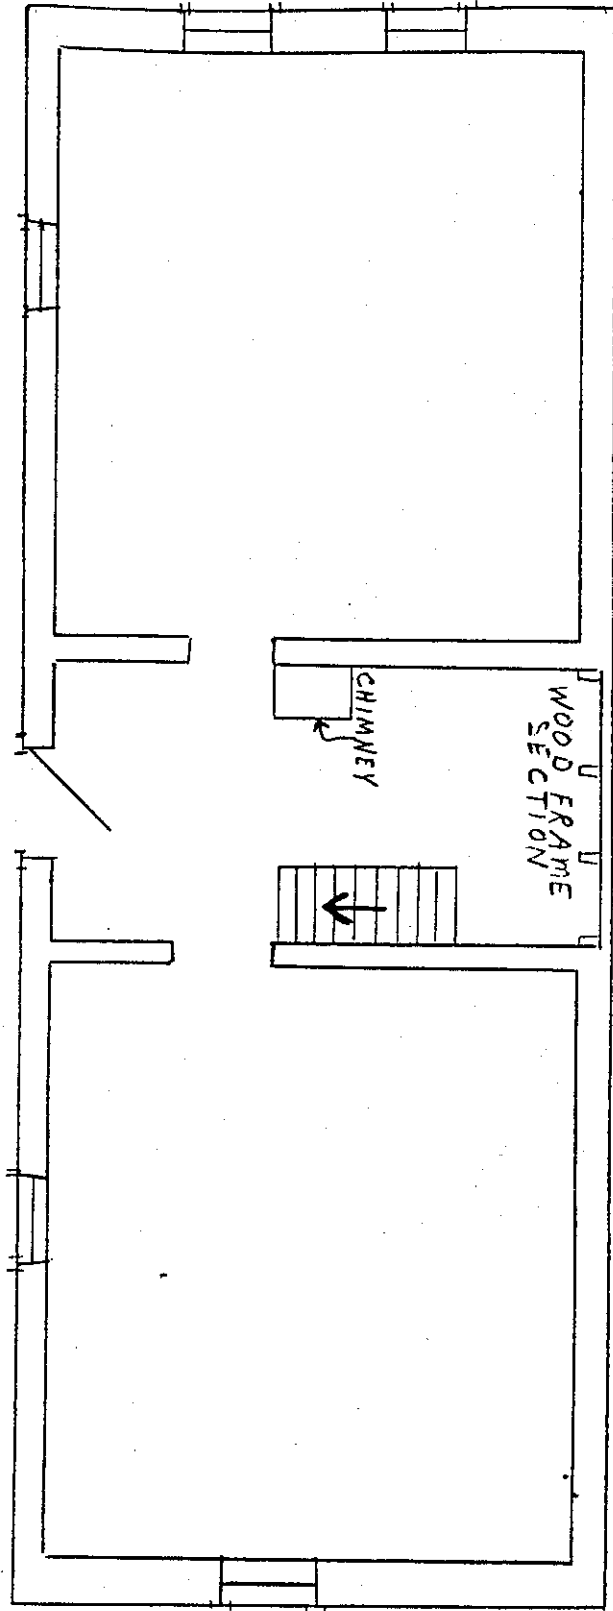
SKETCH OF 3 BAY LINEAR CZECH HOUSE

JOS. PECHAN LOG HOUSE

□ = 1 ft.

The Frantisek (Frank) Pechan House is a one-story coaxial 3-bay log structure sited facing east on a vacant farm about one-half mile from the present owner's home. Dimensions of the building are 15'4" by 42'5". Built of horizontal logs hand-hewn to a size of about one-foot square, the walls rest on loose field stones set at the corners. Corner timbering is of carefully-cut full dovetail notches, and the interstices are chinked with mud and grass. Sometime shortly after initial construction, the exterior was sided with clapboard attached by nailer strips. Stock double-hung windows on the south, north, and east facades are in poor condition, but display distinctive pediment-shaped lintels. There is no fenestration on the west axial facade. A single chimney rises from the left interior partition wall of the house. The gable roof is constructed of 21 common rafters spaced about 25 inches apart, covered with horizontal rough boards and wooden shingles. A knee wall the height of a single horizontal log is visible in the loft.

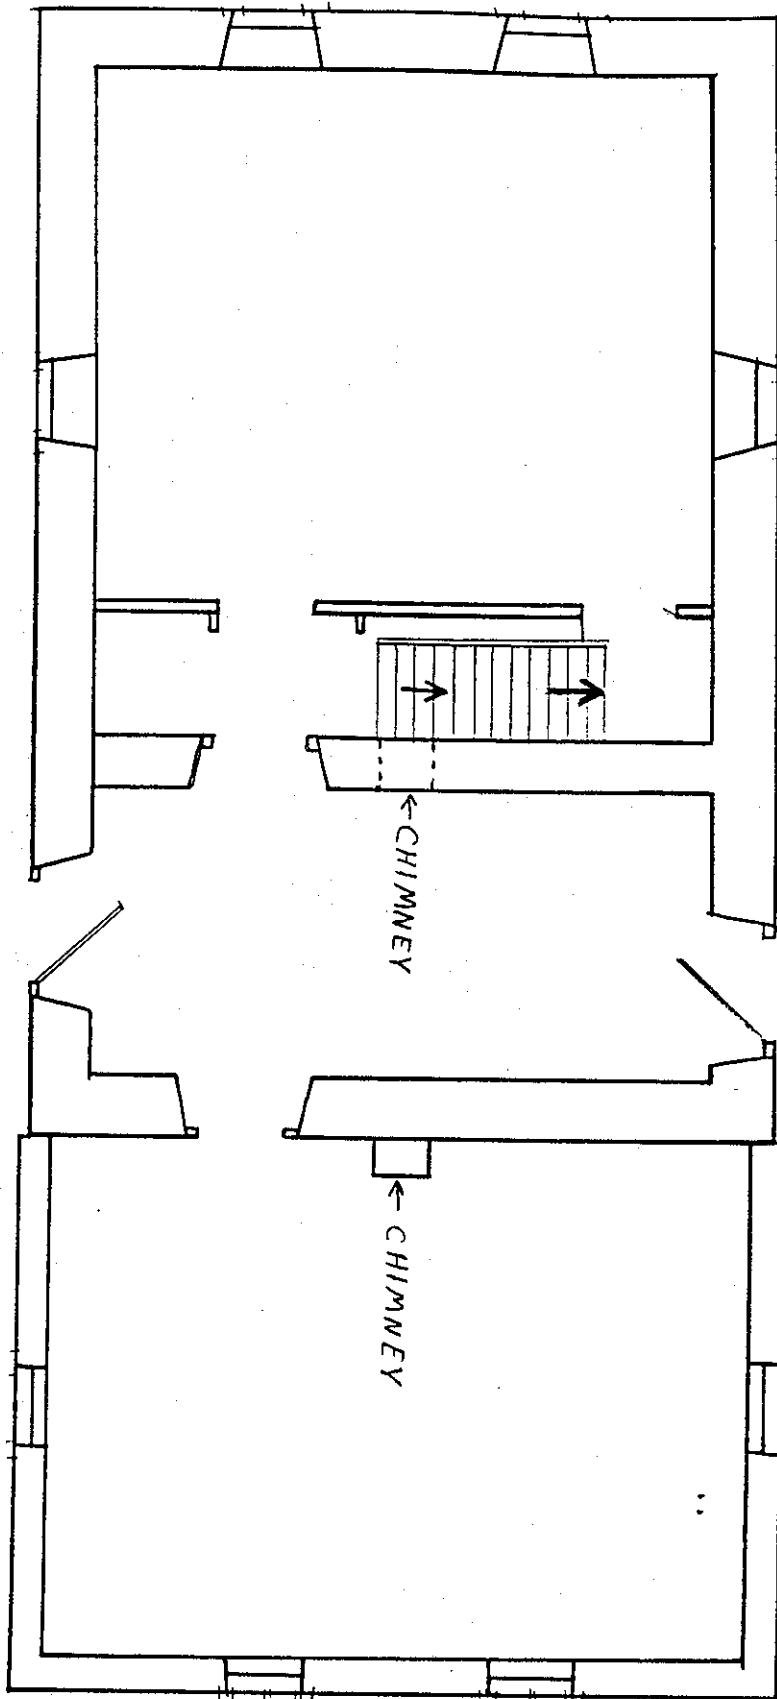
SKETCH OF 2 & 3 BAY LINEAR CZECH HOUSE

□ = 1 FT. JACOB SEDLACEK CHALKROCK & PRESSED BRICK H'SE

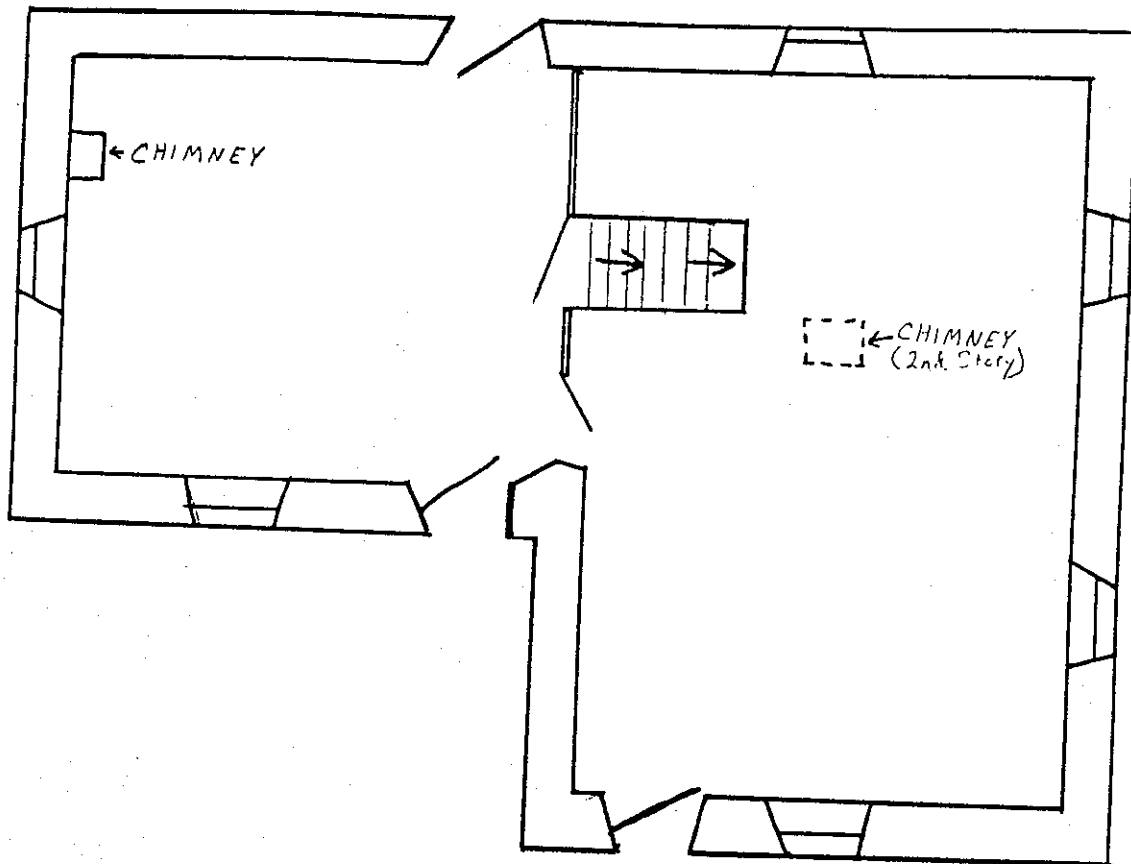
SKETCH OF ANGLO DERIVATION OF THREE BAY, L-SHAPED CZECH HOUSE

□ = 1 ft. WALKER/VELLIK CHALK ROCK H'SE

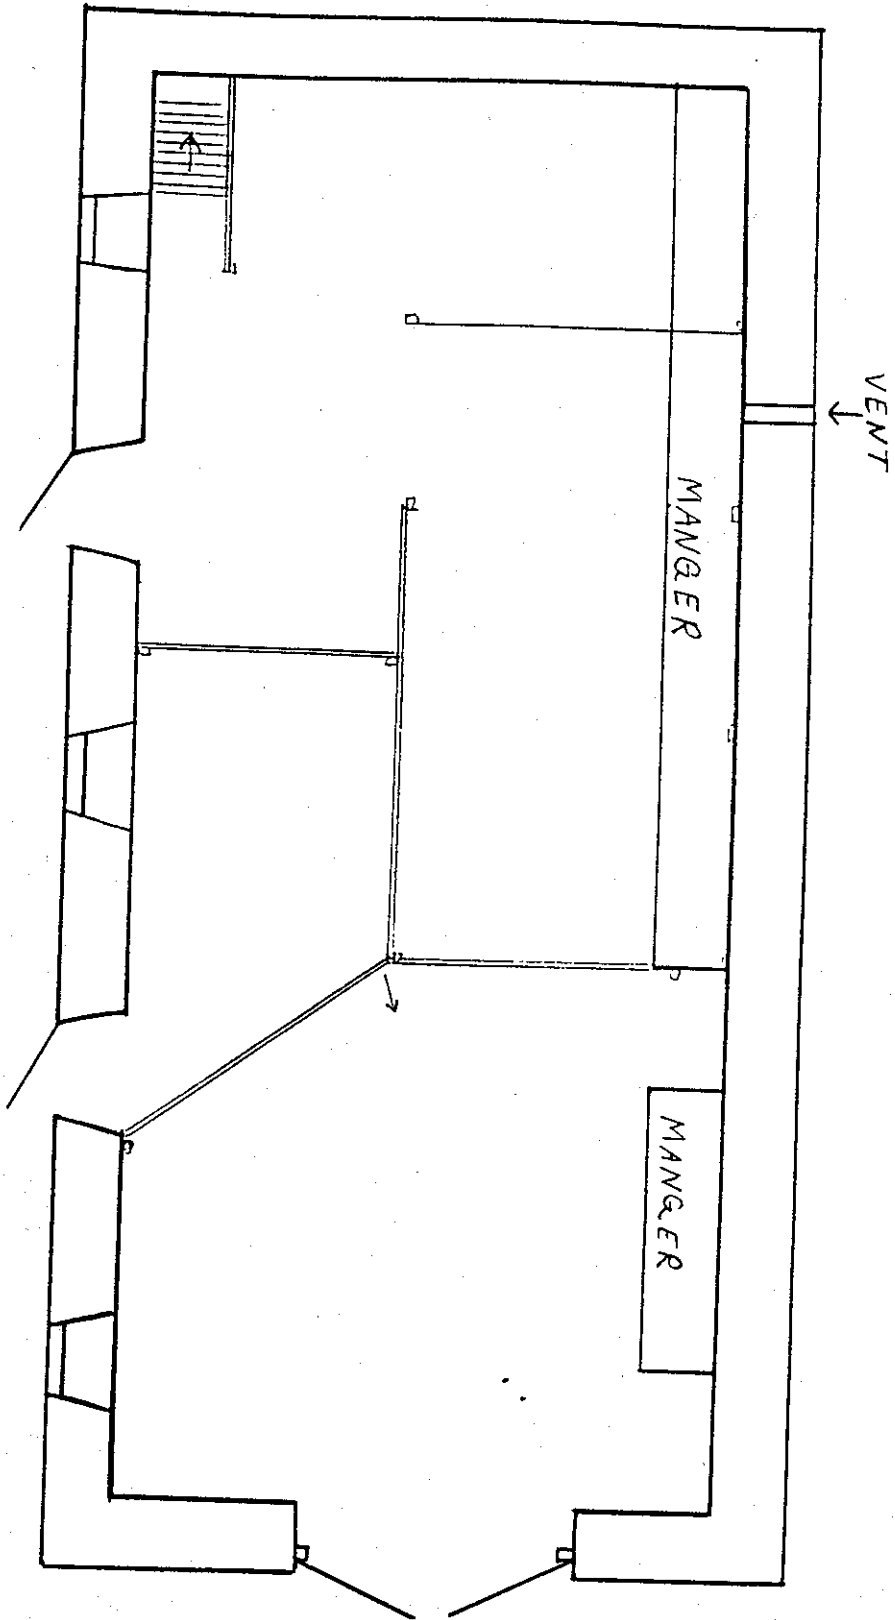
SKETCH OF CZECH BARN

□ = 1 ft. MATHIAS MERK VAN RUBBLE STONE BARN

A second type of barn found among the early Czech farms in South Dakota is a long, rectangular form generally with entrances along only the axial walls. Some of these structures appear to be house/barns; however, their use as dwellings has long been abandoned. These barns utilize the same materials, techniques, and features discussed above, but their overall form is different. The long dimensions and seemingly linear design resemble in part old world barns. Axial facades vary in length from 44 feet to an extreme of 160 feet. The latter structure, the Frydrych Barn (CZ 25, see continuation sheets), is a wood frame and rubblestone bank barn with several axial openings including a second-story drive-in door for loading hay. But, it also incorporates a gable-end entrance on the first story. Aside from the masonry barns, a log house/barn has been recorded; nevertheless, due to relocation and alteration it is not eligible for the Register.

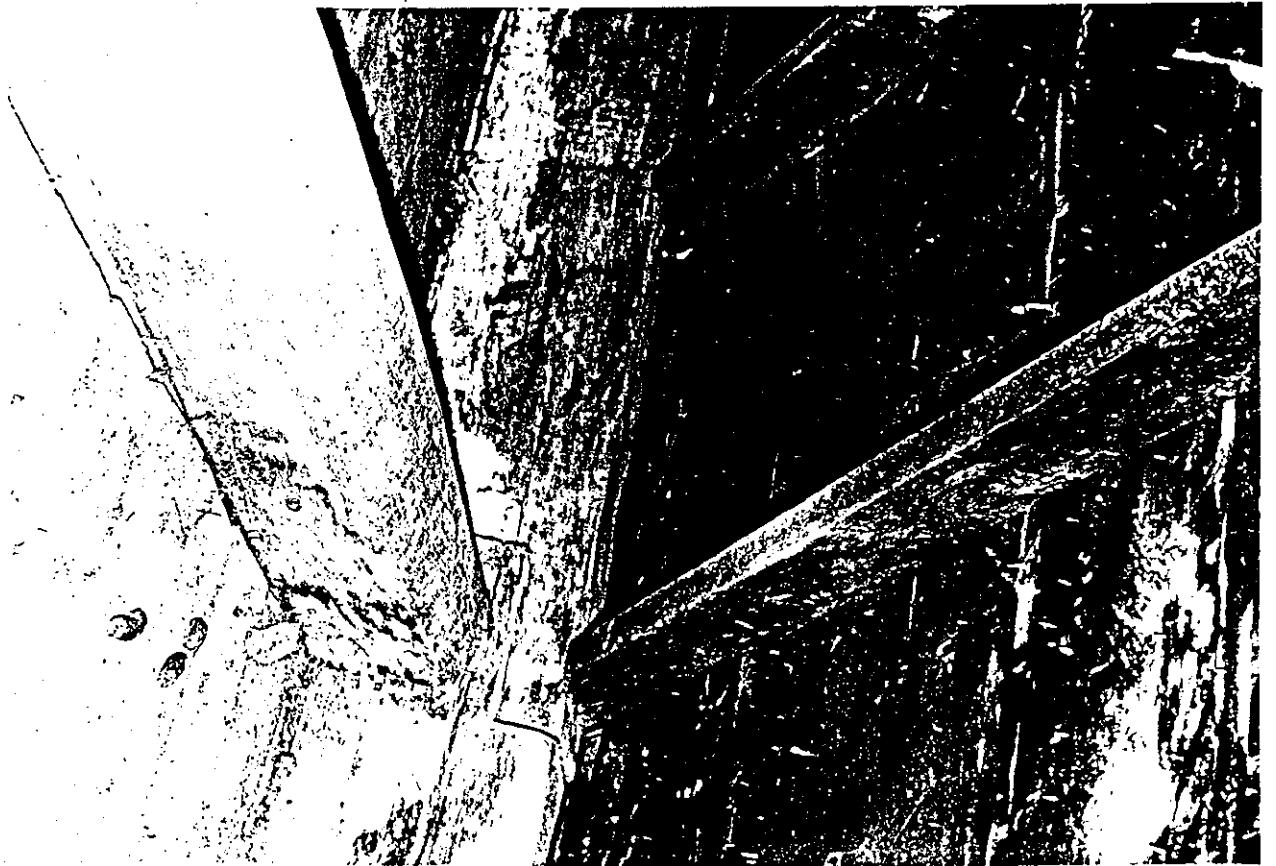
State Historical Preservation Center
Interior of loft, detail of knee wall
Photo # 45. (CZ 5)

State Historical Preservation Center
Interior of loft, detail of knee wall
Photo # 46. (CZ 5)

A distinctive element is a one to one-and-a-half foot high stone or log "knee wall" that is a vertical extension of the exterior walls above the ceiling joists. This device allows a taller roof line and greater interior space, since the rafters are set atop of this wall above the floor of the loft. This treatment may also provide better insulation for the upper sleeping chamber. Knee walls are not universally found on Czech-built structures in this state, though they are quite common. Also noteworthy is that none of the Bohemian buildings found in Nebraska have exhibited this feature.

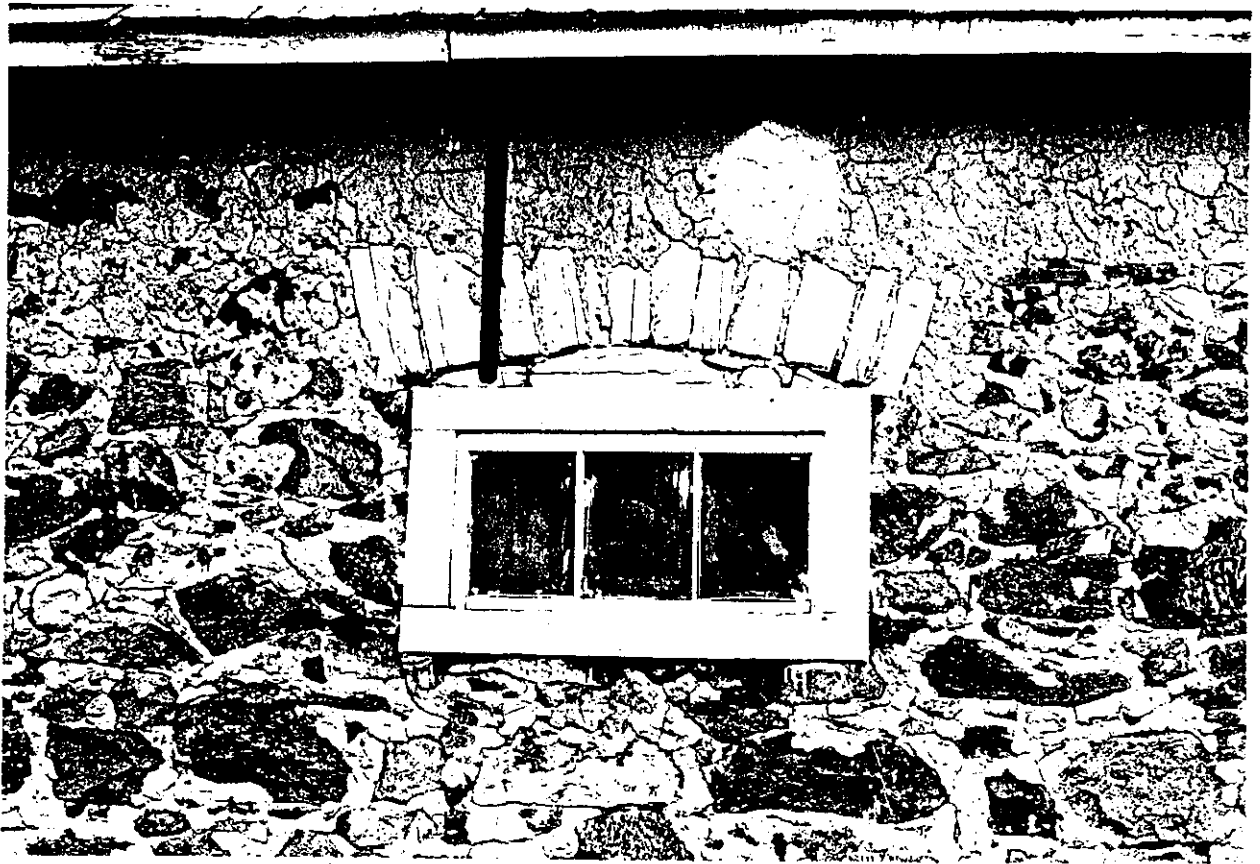
State Historical Preservation Center
West facade, detail of jack arches
Photo # 52. (CZ 18)

invariably include carefully-crafted brick, stone, or chalkrock jack arches above the windows and doors. Although rare, pediment-shaped hand cut wooden lintels were found on examples of both log and earthen structures.

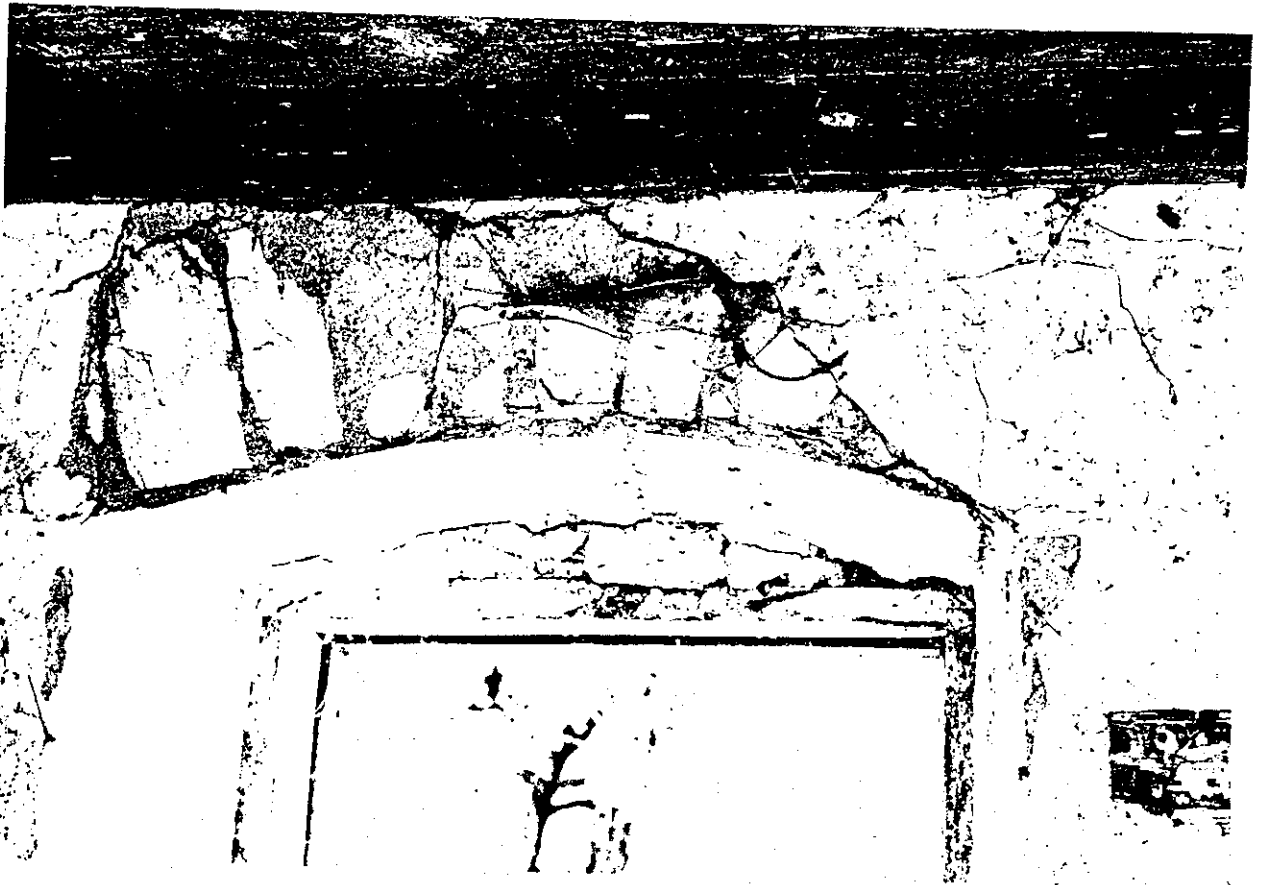
State Historical Preservation Center
Interior, detail of jack arches
Photo # 51. (CZ10-a)

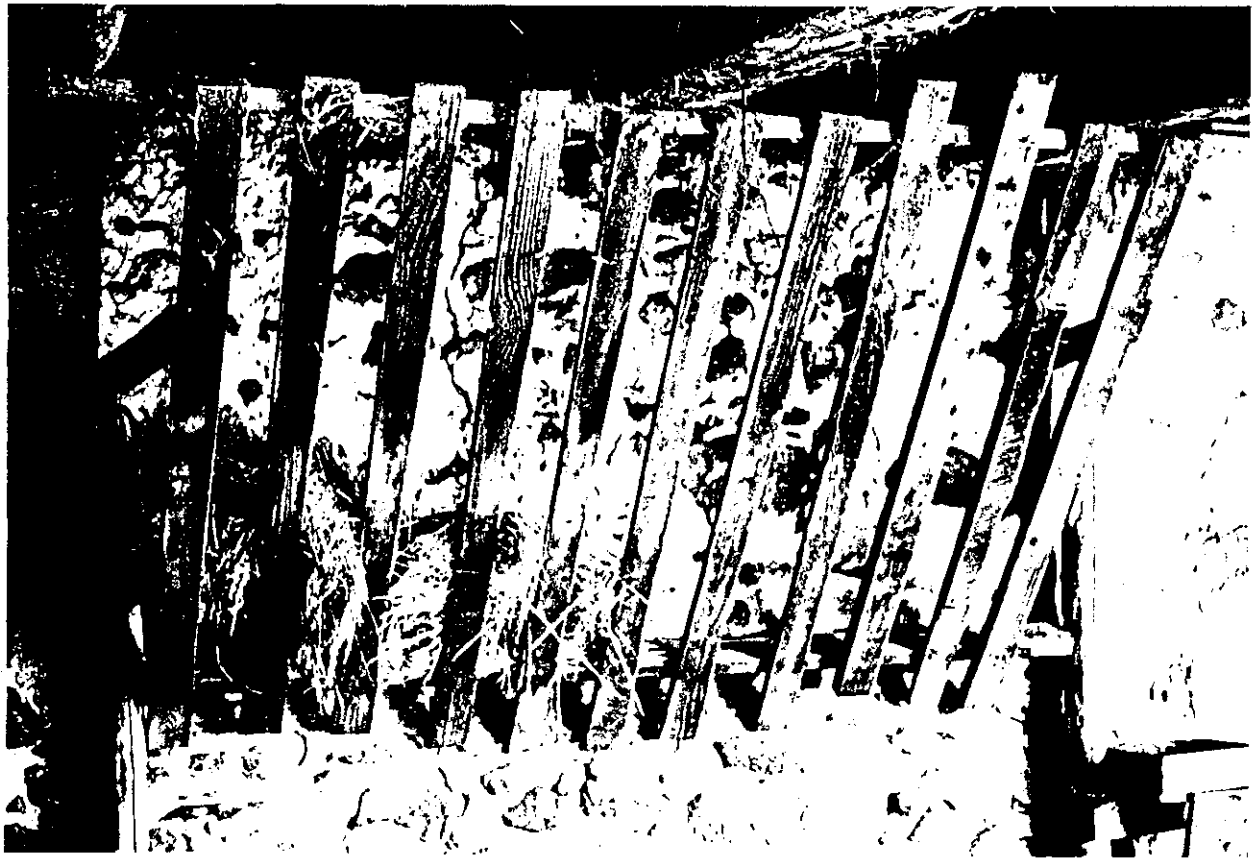
State Historical Preservation Center
Interior, detail of manger
Photo # 54. (CZ 13)

Significant in architecture, the Merkwan House-Barn is the only known eligible example of Czech House-Barns in the state. Also, its well-preserved interior features, such as the manger and the ladder-stair are indicative of typical Czech barn furnishings. The present owner, a great-grandson of the builder has kept the structure in a good state of repair and still utilizes it in limited ways in the farm operation. It is one of the best surviving Czech barns in the survey area.

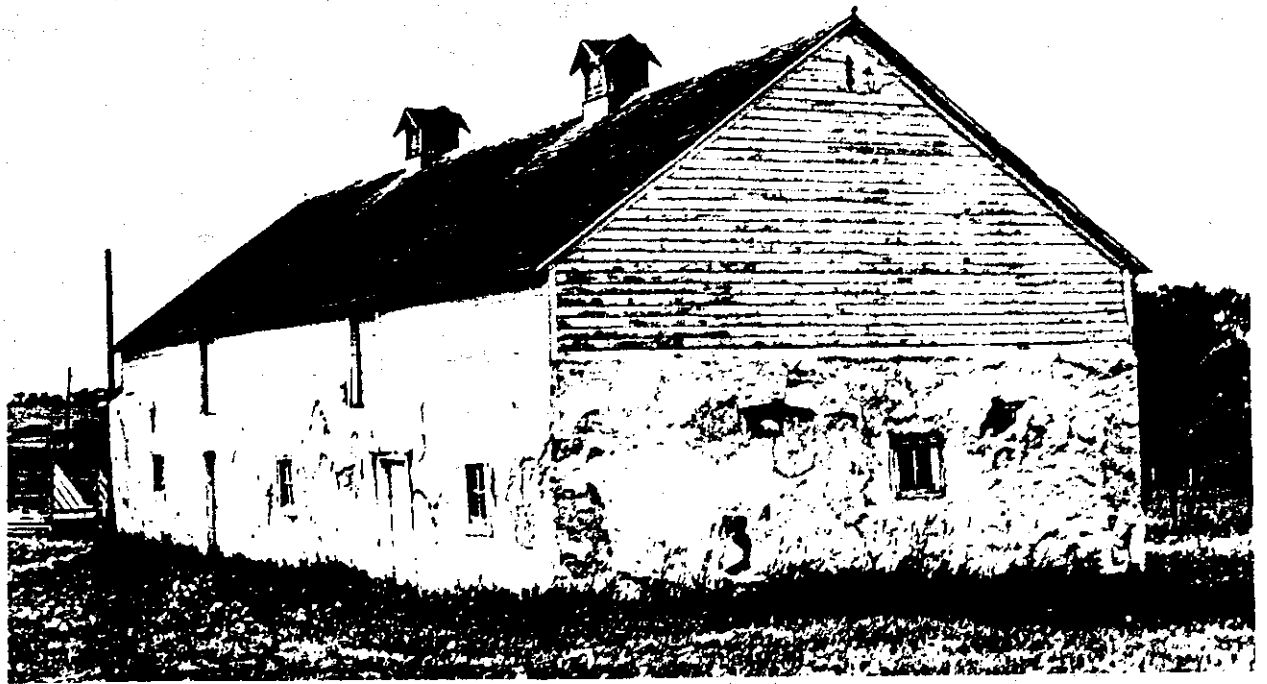
SITE NAME: FRANK SVATOS
CZ SURVEY #: 16

SITE PLAN (Complete inventory of all structures, their function, dates & details of construction, and surrounding vegetation) WITH NORTH ARROW

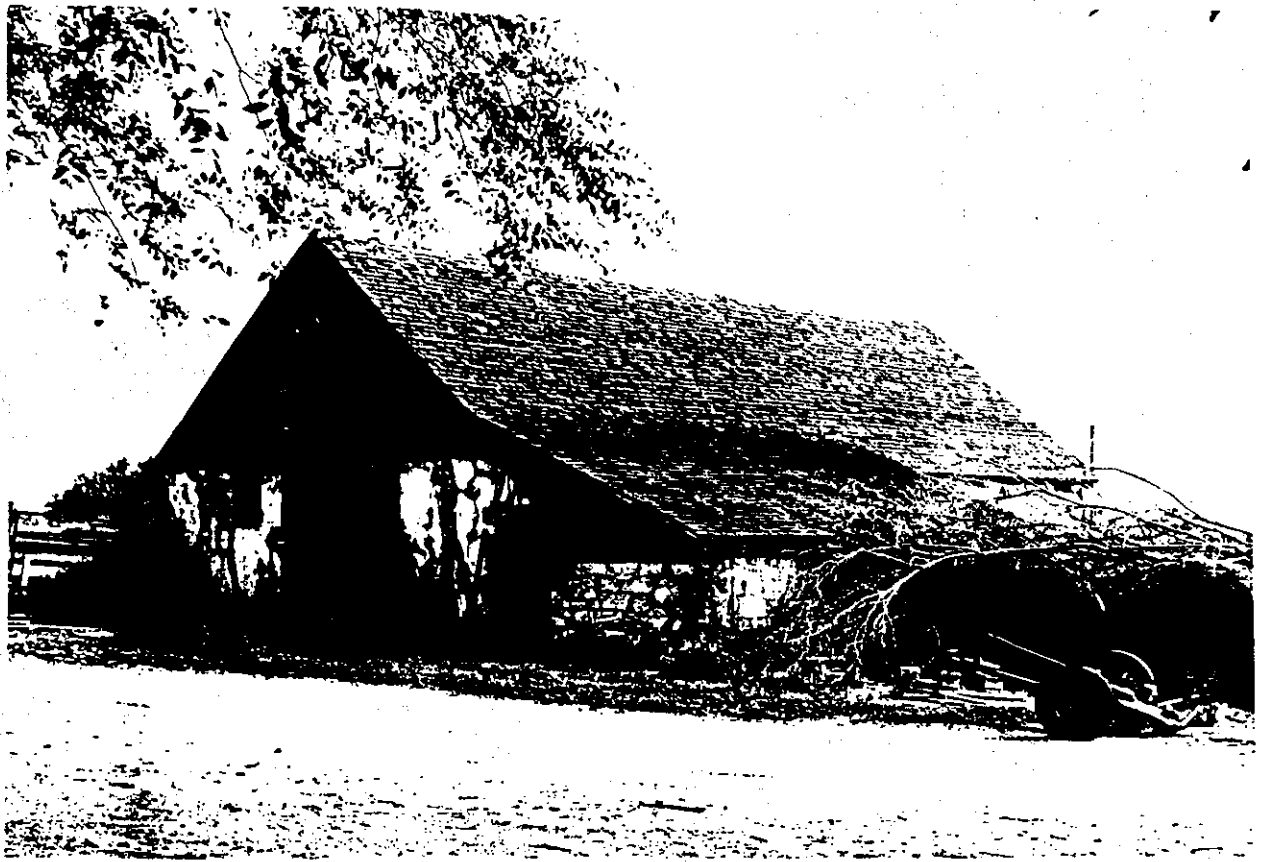
SITE NAME: J. L. HRUSKA
 CZ SURVEY #: 21 a/b

SITE PLAN (Complete inventory of all structures, their function, dates & details of construction, and surrounding vegetation) WITH NORTH ARROW

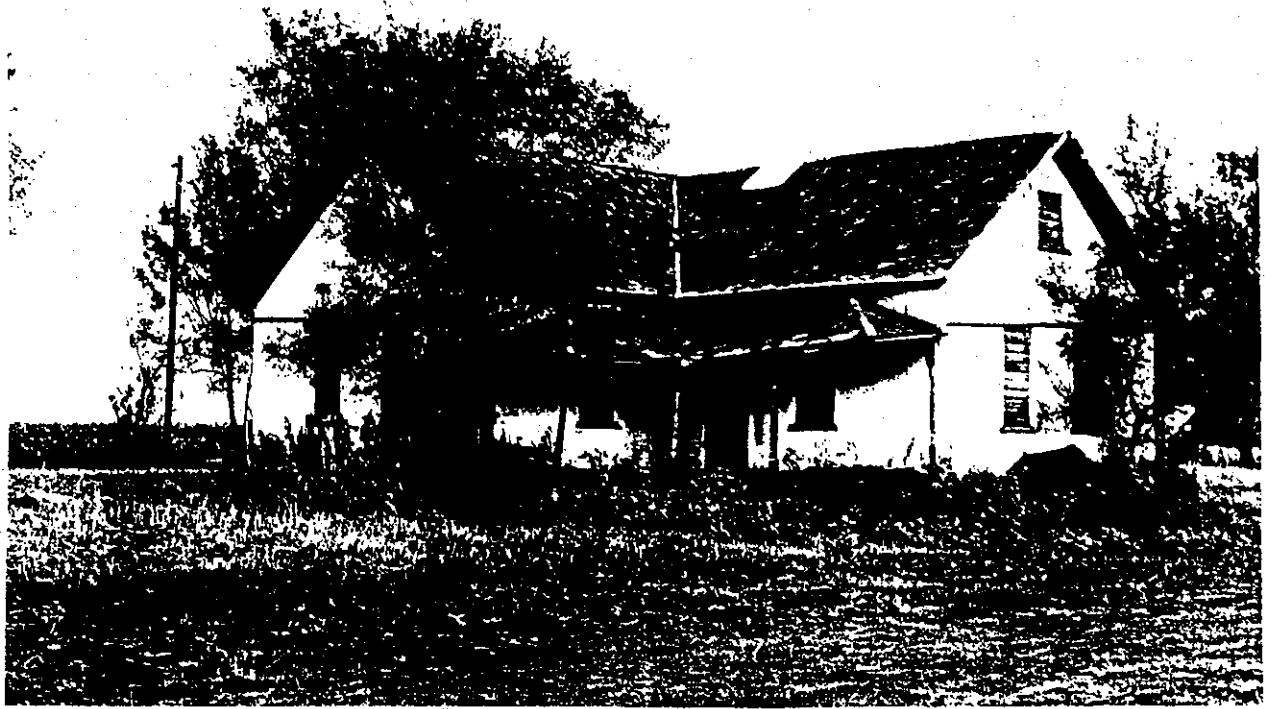
SITE NAME: John Harkl Chalkrock House
CZ SURVEY #: 23

SITE PLAN (Complete inventory of all structures, their function, dates & details of construction, and surrounding vegetation) WITH NORTH ARROW

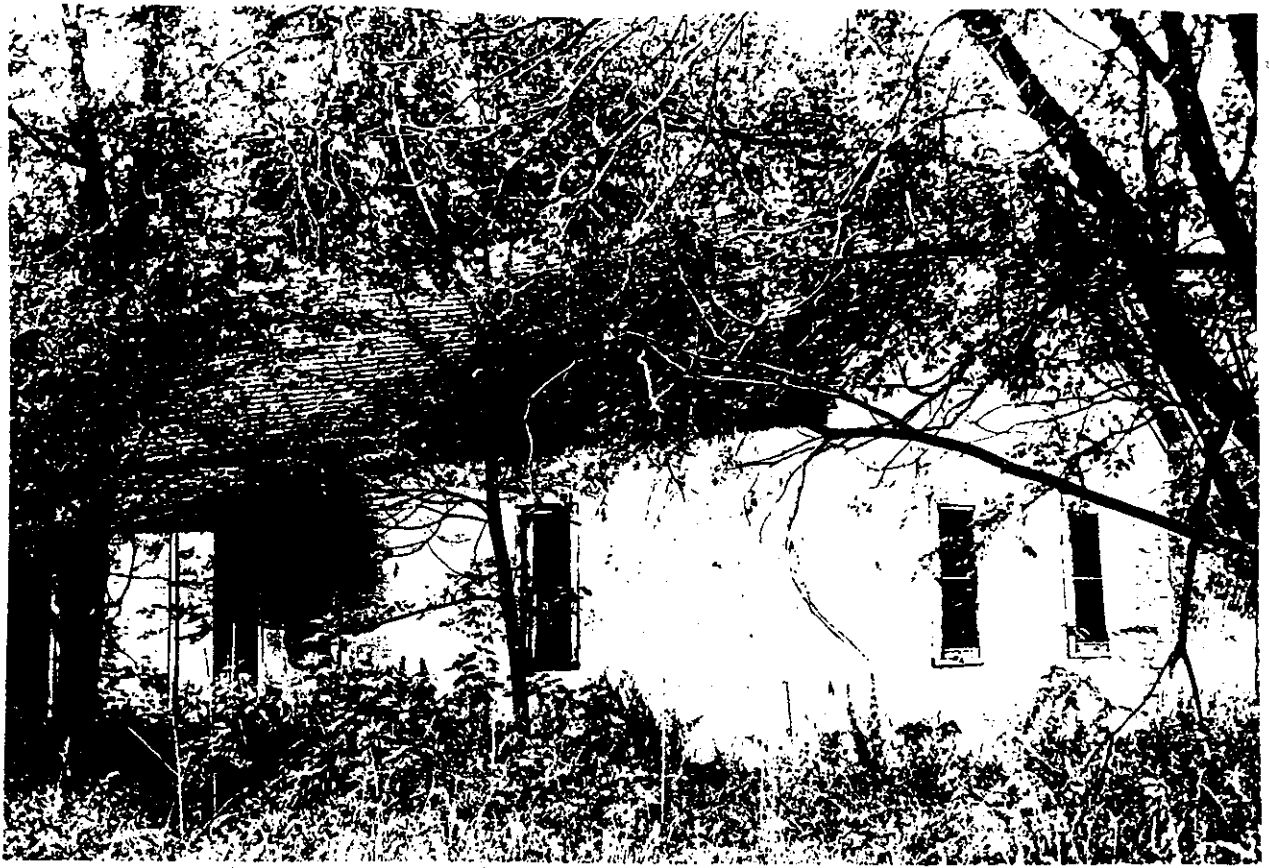
SITE NAME: JACOB SEDLACEK
 CZ SURVEY #: 24

SITE PLAN (Complete inventory of all structures, their function, dates & details of construction, and surrounding vegetation) WITH NORTH ARROW

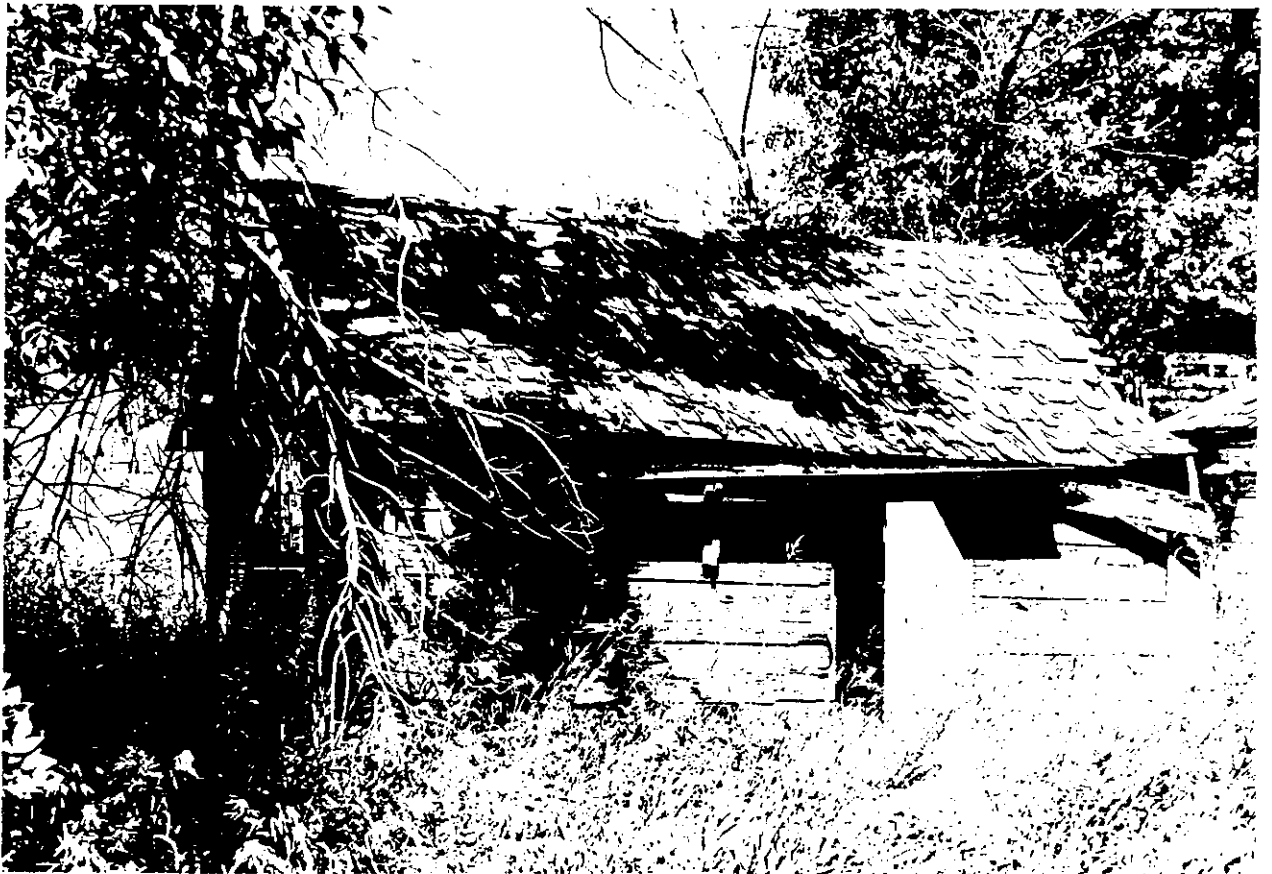
SD State Historical Preservation Center
North and east facades, facing southwest
Photo # 5. (CZ25-1)

House, Frydrych Farmstead
Cleveland Twp., Bon Homme Co., South Dakota
Gerald Wolff
1983

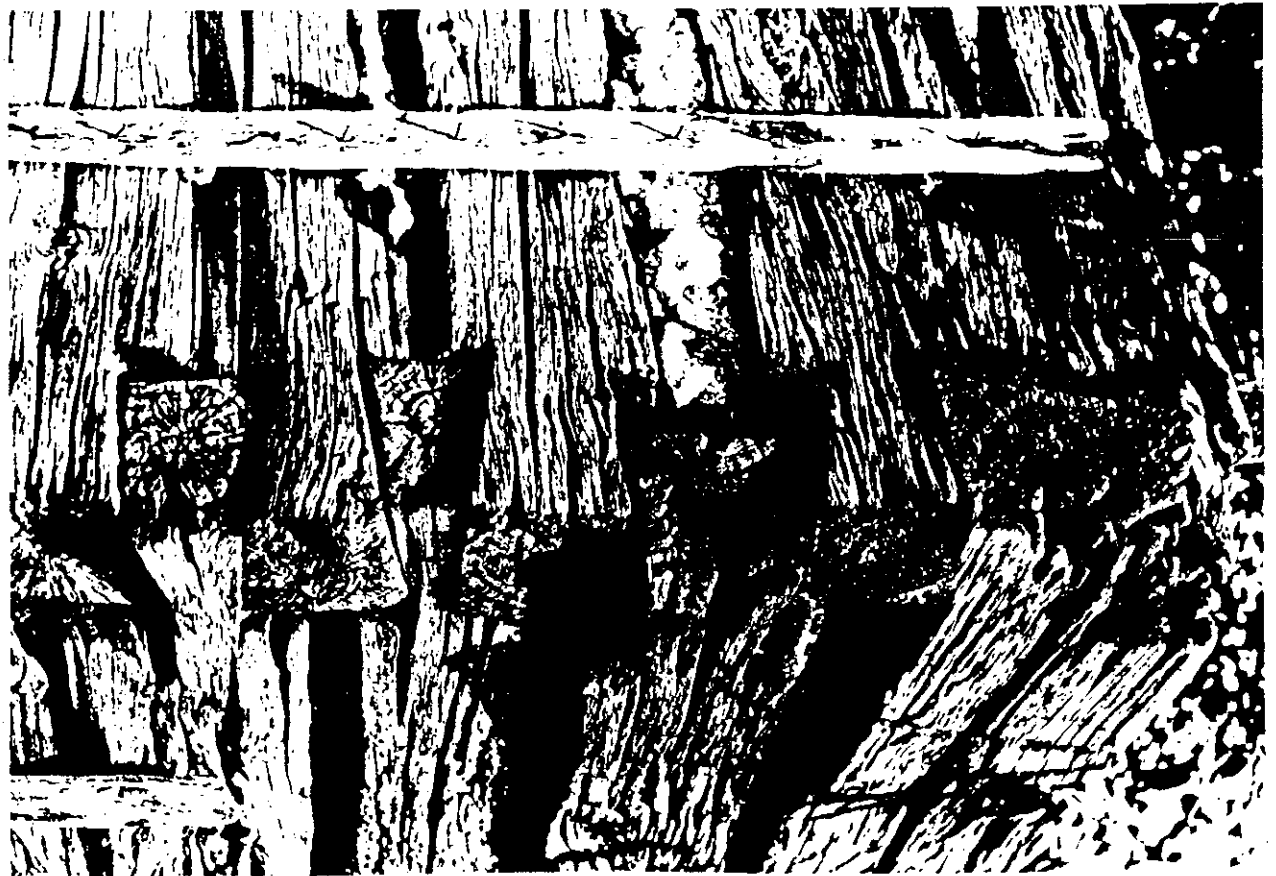
SD State Historical Preservation Center
Detail of corner notching, south facade
Photo # 12 (CZ25-17)

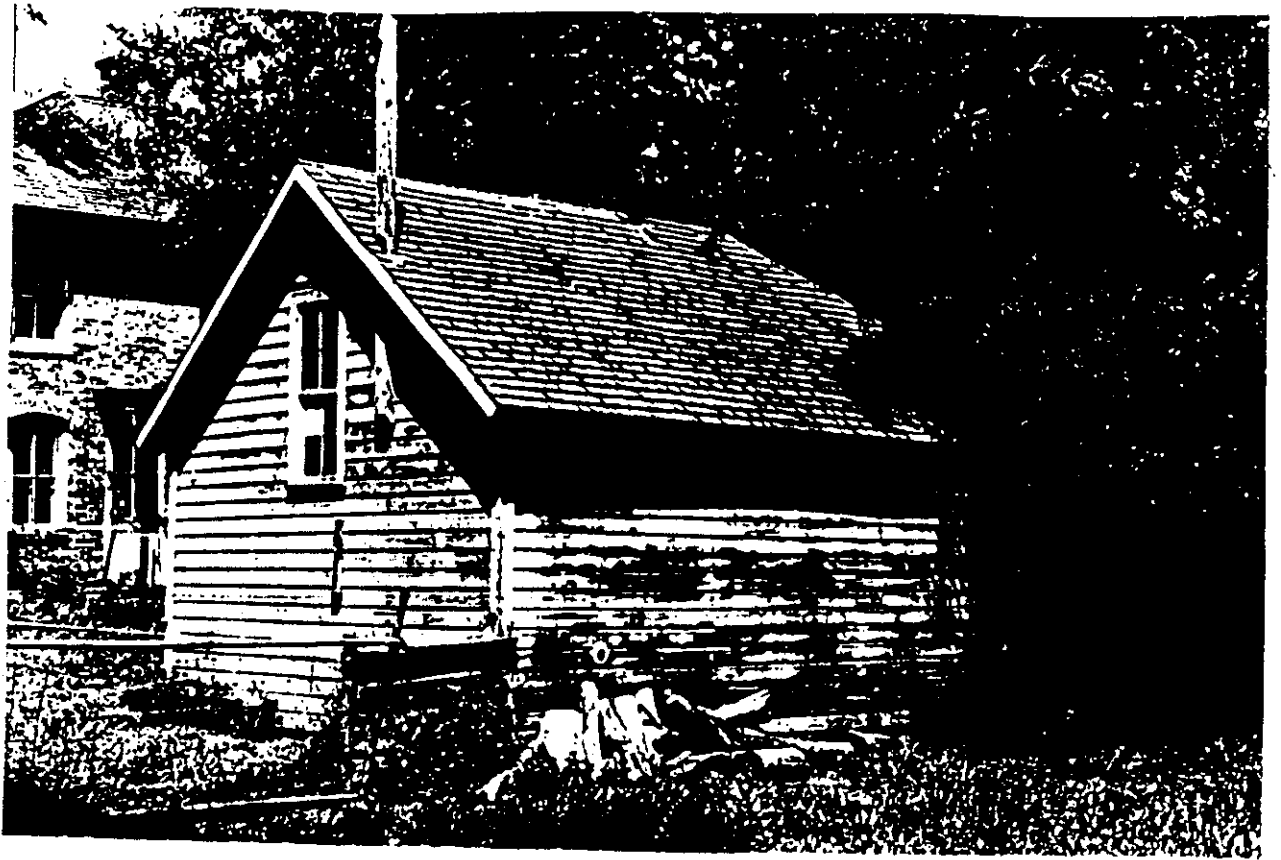
Log House, Frydrych Farmstead
Cleveland Twp., Bon Homme Co., South Dakota
Gerald Wolff
1983

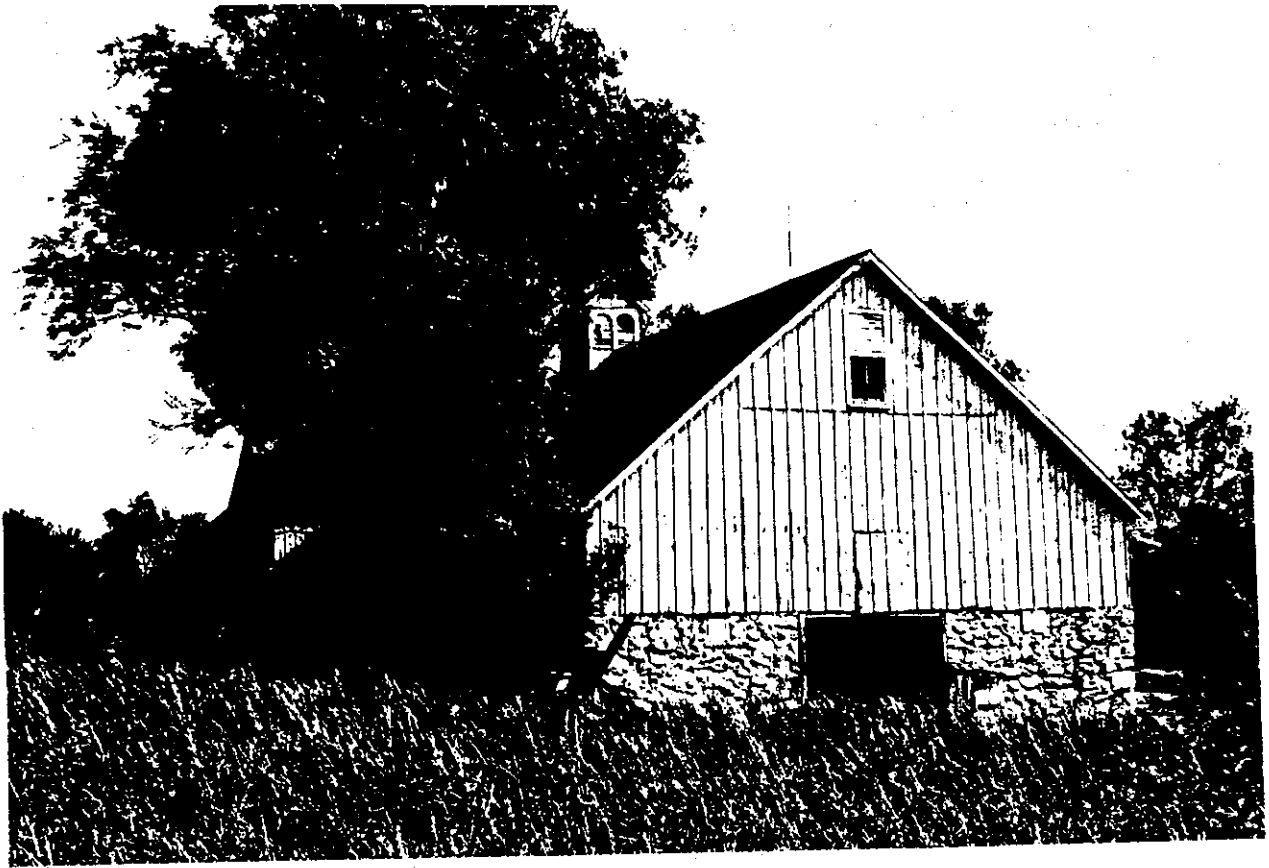
SD State Historical Preservation Center
South and east facades, facing northwest
Photo # 19. (CZ25-4)

Barn, Frydrych Farmstead
Cleveland Twp., Bon Homme Co., South Dakota
Rolene Schliesman
1985
